Manhole Inspection Summary

Manhole # S65O__018MH

Insp Date: **4/23/08 11:50 AM**

Location Address: **1316 Bonsal St.**

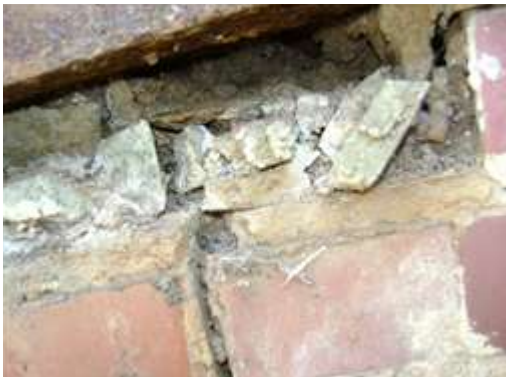
Defect 3

loose mortar under frame

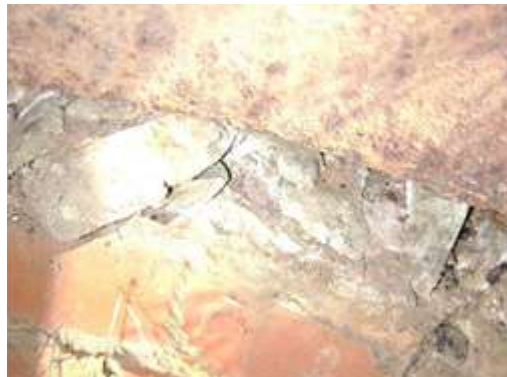
Defect 1

Condition: ☐ Sound ☐ Cracked ☐ Root Intrusion ☒ **Loose Brick** ☒ **Deteriorated**

Loose Bricks

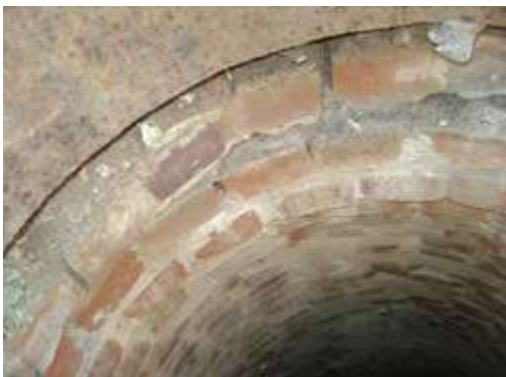
Defect 4

opening at chimney/frame joint

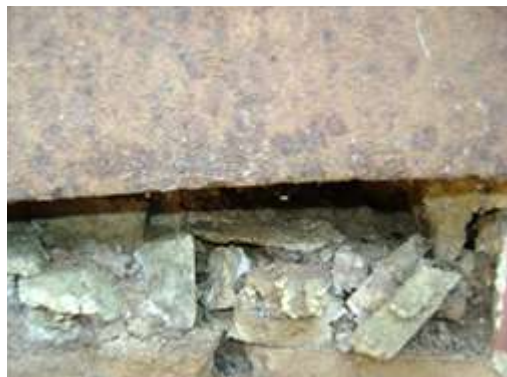
Defect 2

loose mortar under frame

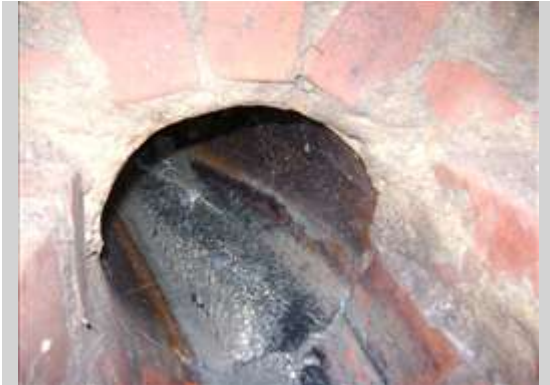
12 O'Clock Outflow

Deposits: ☐ None ☐ Mud ☐ Sludge ☐ Debris ☒ **Grease**

Silt Depth: **0.125** (in.) Deposits Extent: **Light**

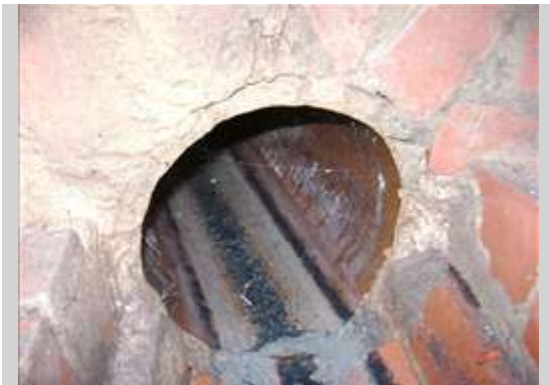
6 O'Clock Inflow

Deposits: ☐ None ☐ Mud ☐ Sludge ☐ Debris ☒ **Grease**

Silt Depth: **0.125** (in.) Deposits Extent: **Light**
